Test of: SPW600 Tilt & Turn Inward Opening (AluPilot Gearing)

Enhanced security performance requirements for windows

A Report To:
Senior Architectural Systems
Eland Road, Denaby Main, Doncaster, DN12 4HA

Document Reference:
WIL 509165

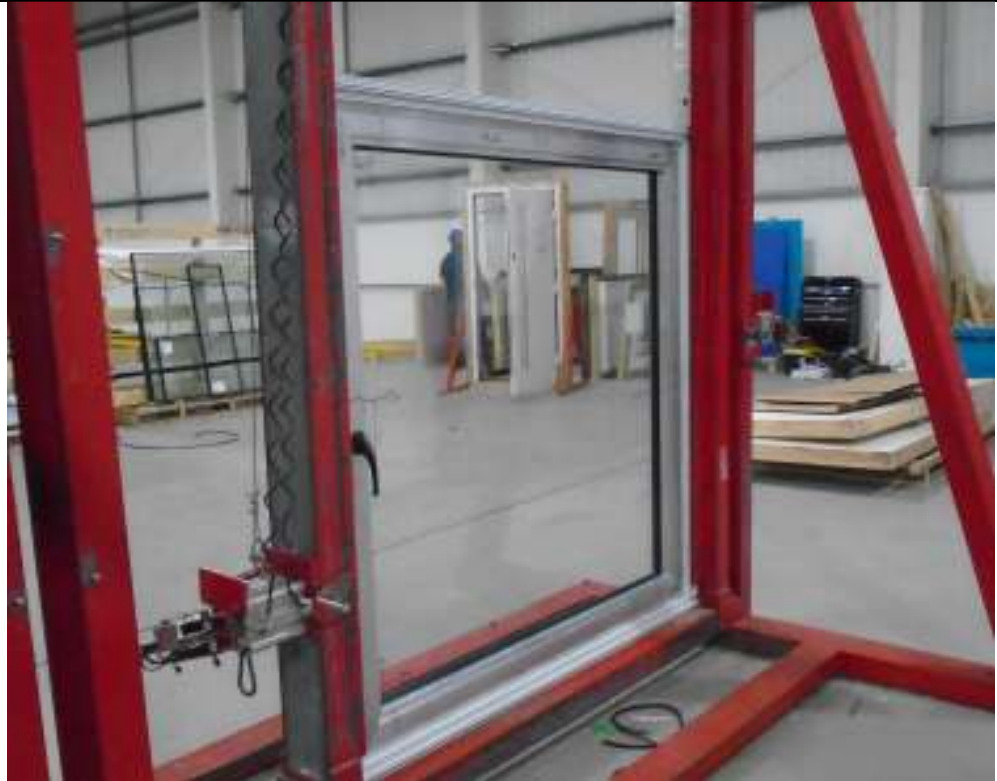
**The internal face
of the sample**

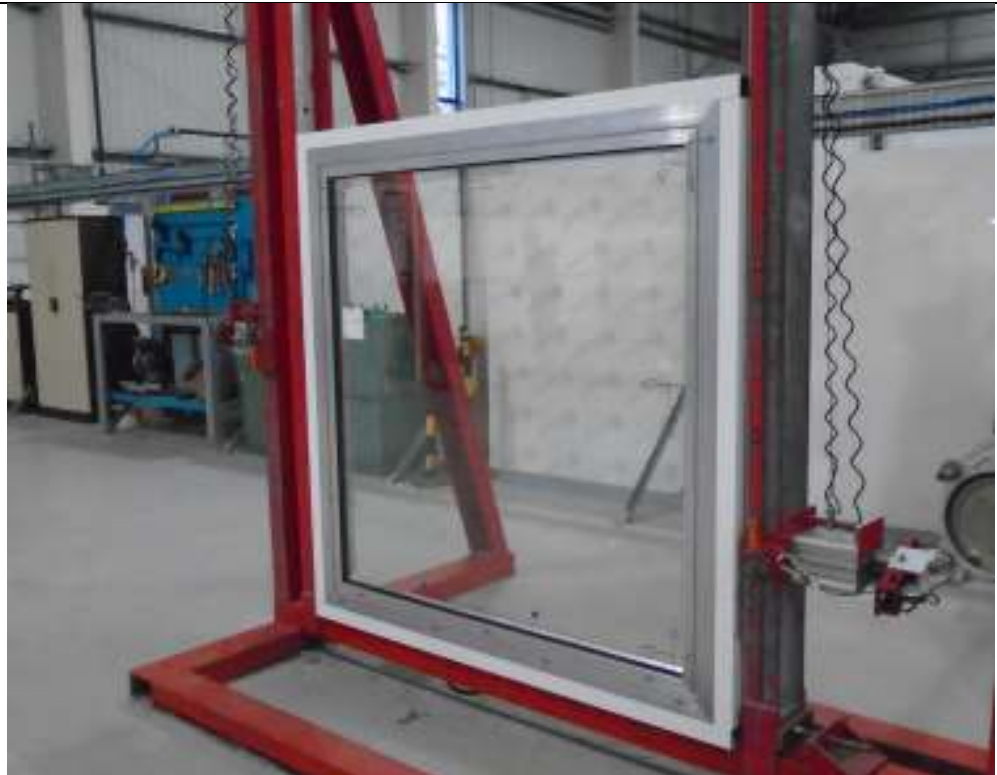
**The external face
of the sample**

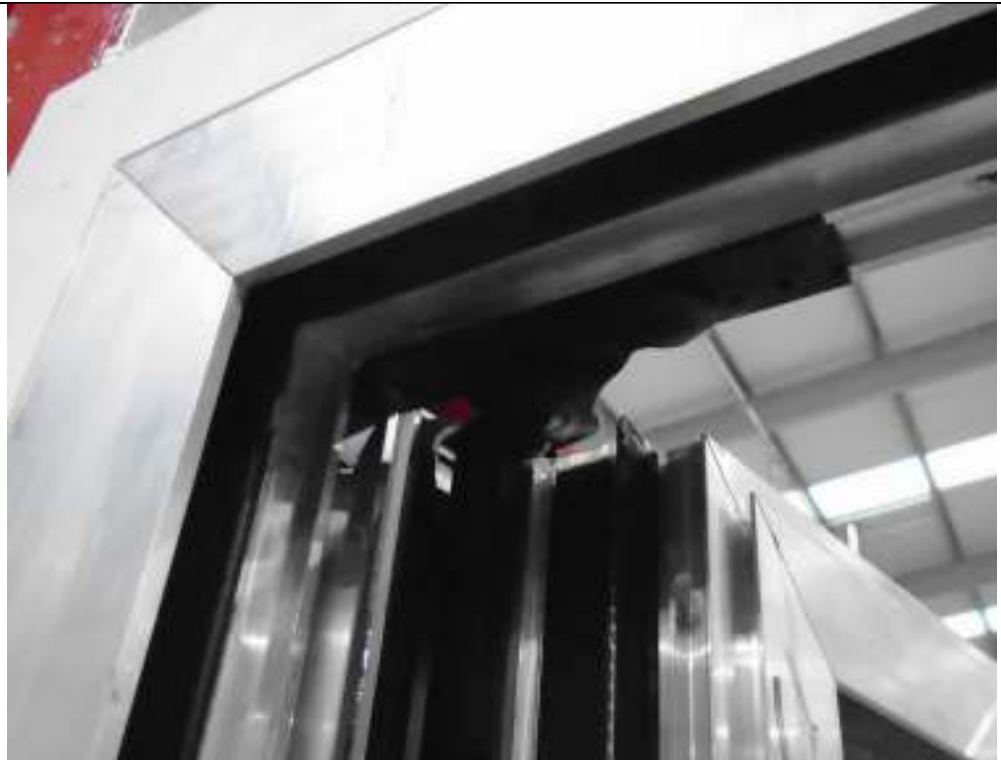
Sample hinge

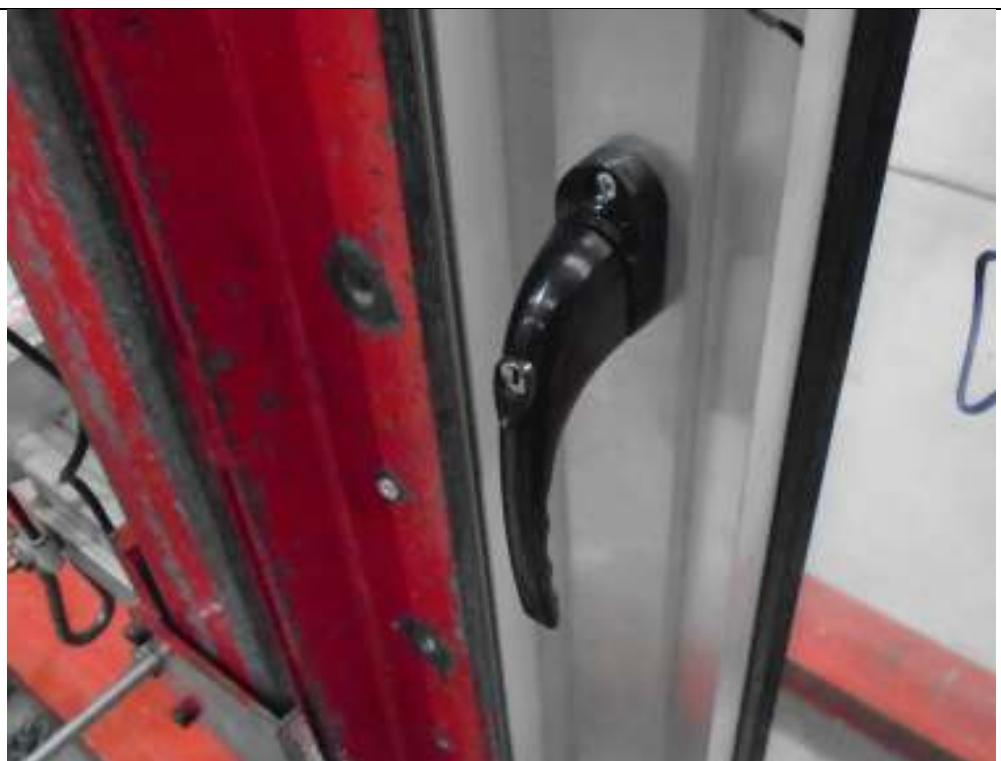
Sample handle

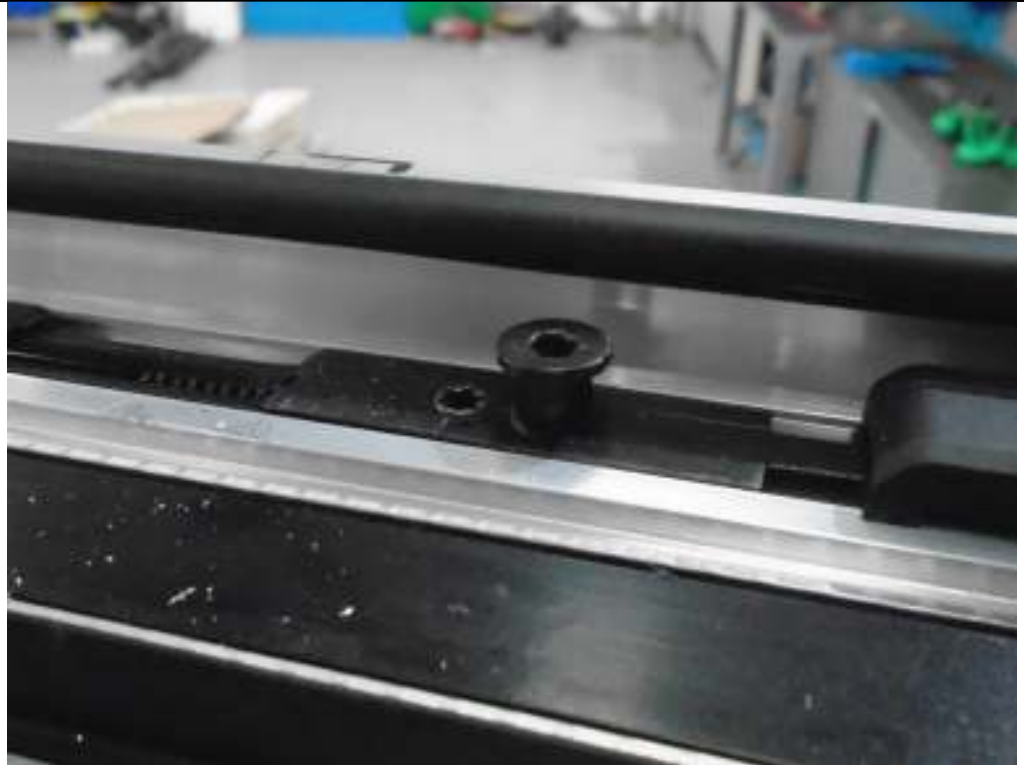
**Sample locking
cam**

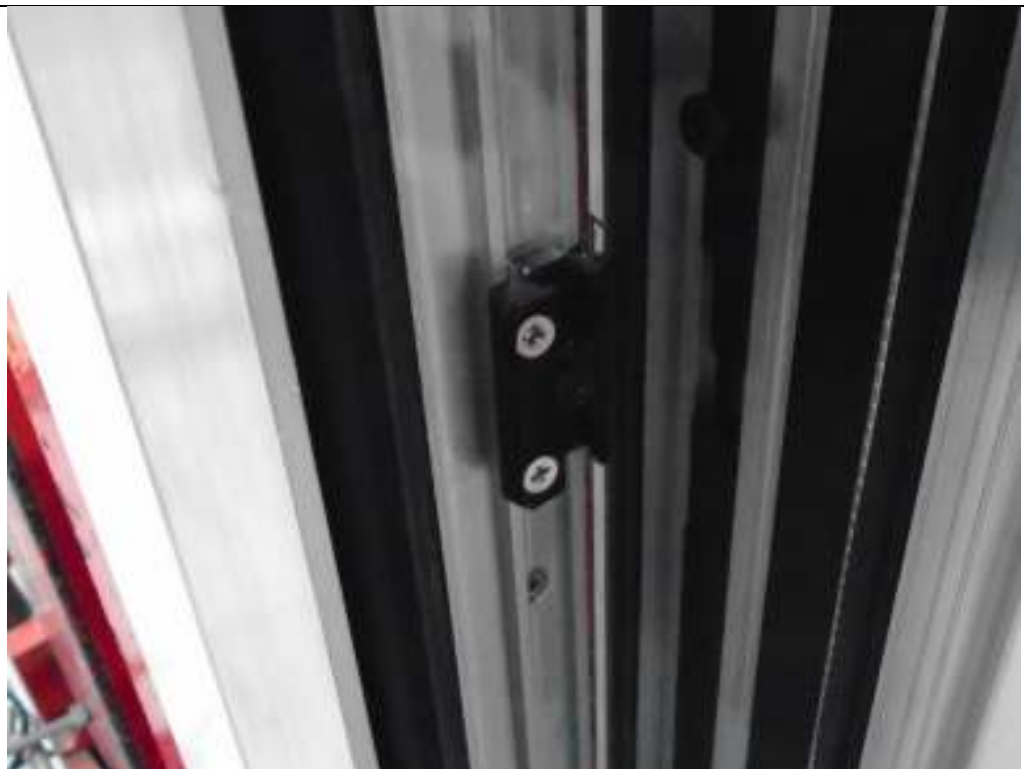
Sample keep

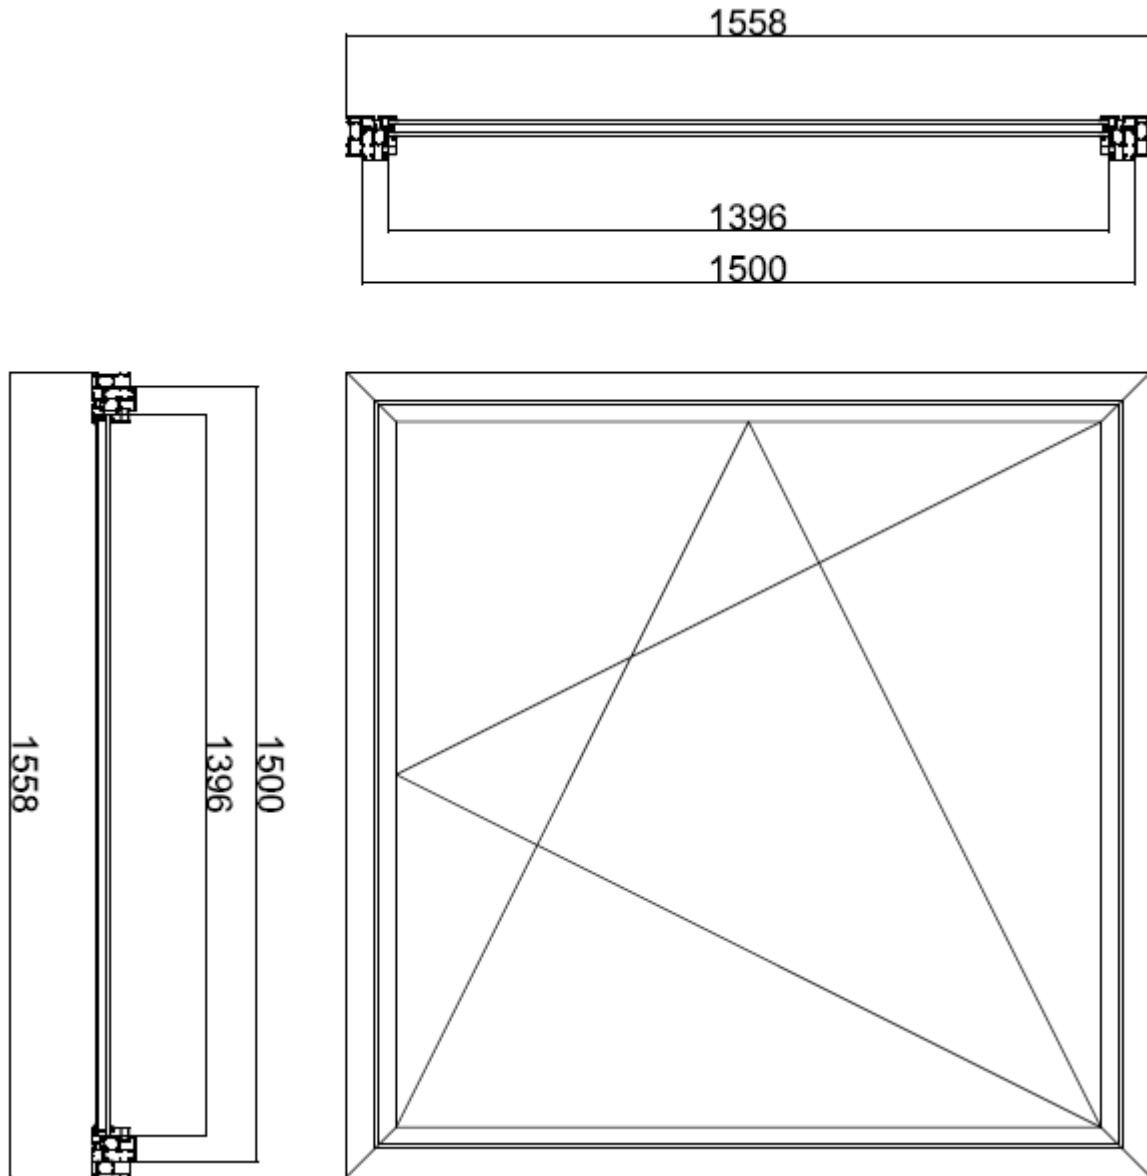
Figure 1- General Elevation of Test Specimen (External Face)

(Refer to Figures 1 to 3)
 (All values are nominal unless stated otherwise)
 (All other details are as stated by the sponsor)

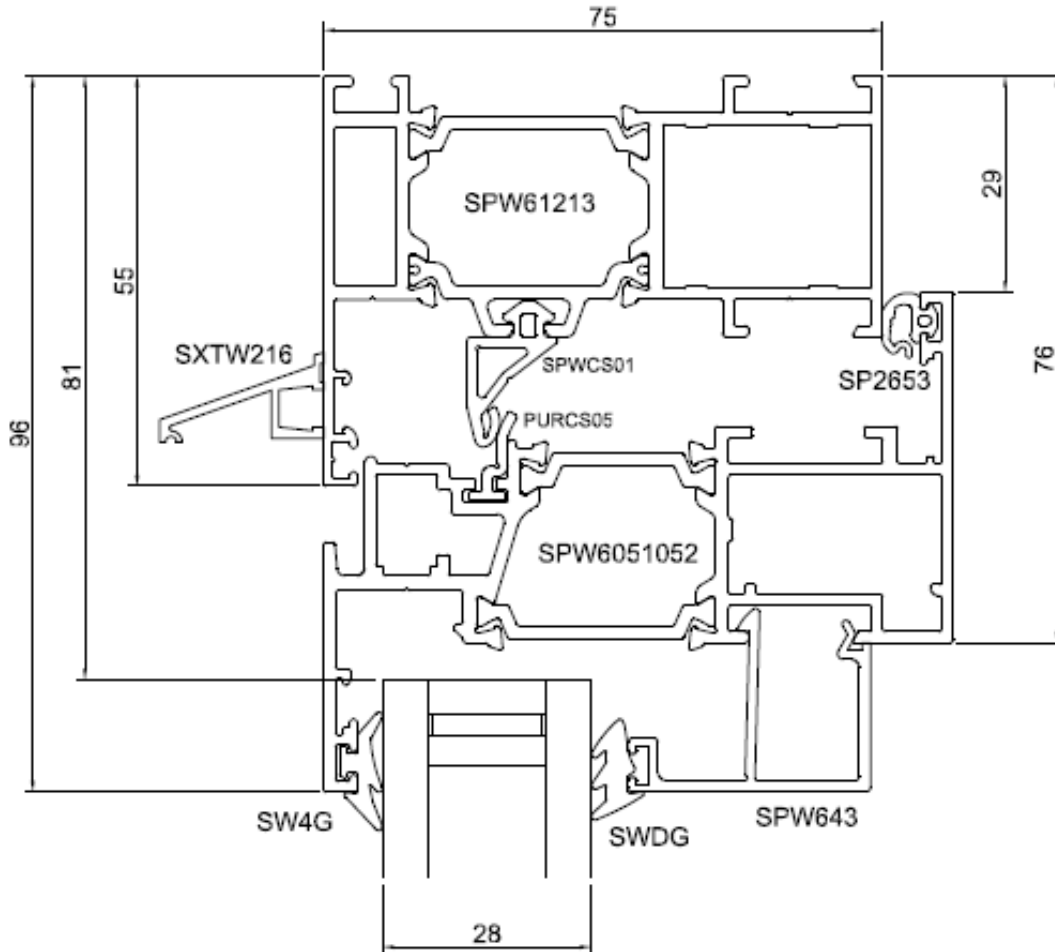
Figure 2 – Head detail

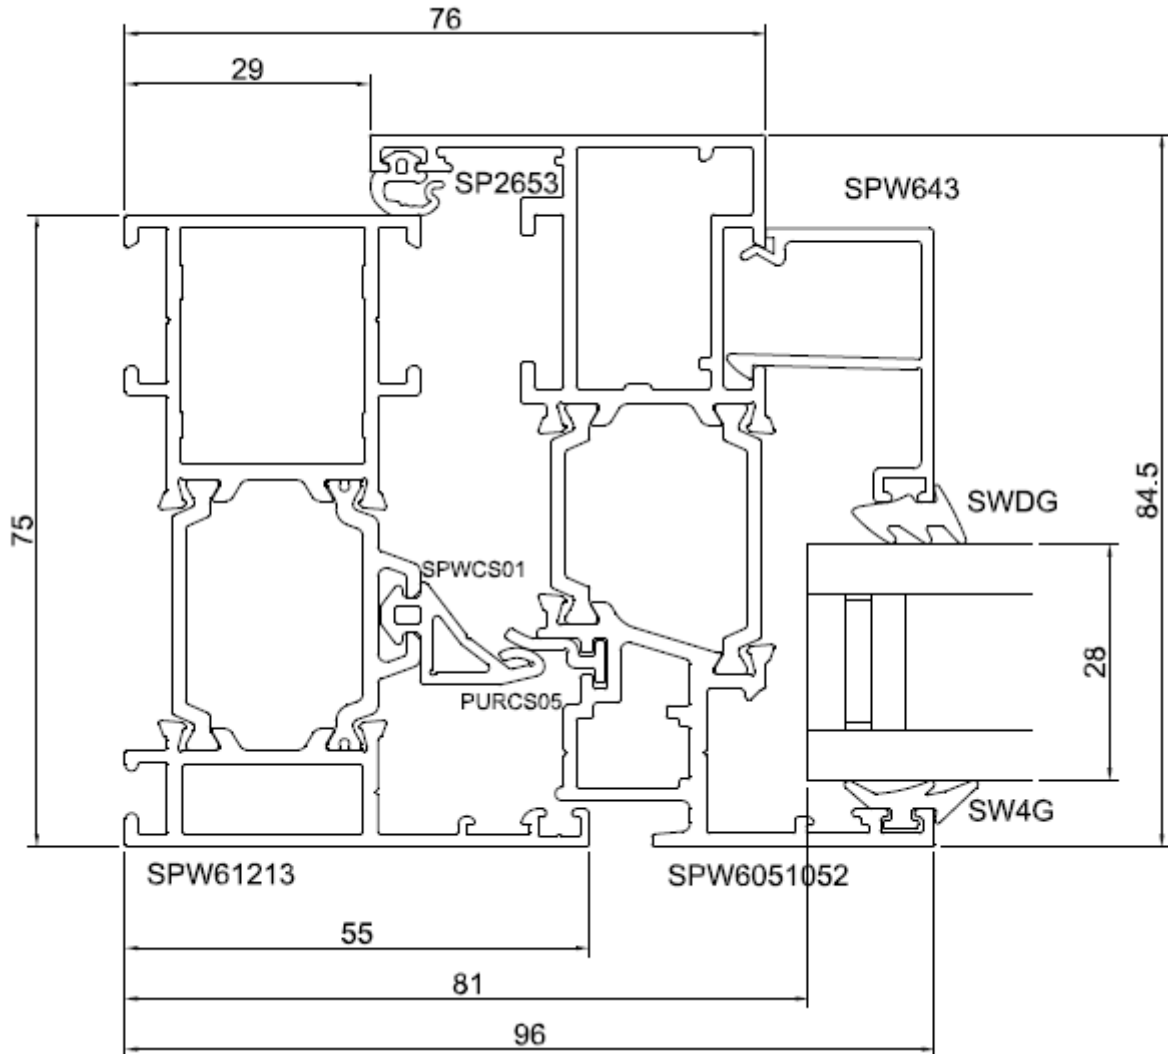
Figure 3 – Jamb detail
