PAS 24:2016

Test of: Ali Vu Multilight Casement

Enhanced security performance requirements for windows

Document Reference:
WIL 388463

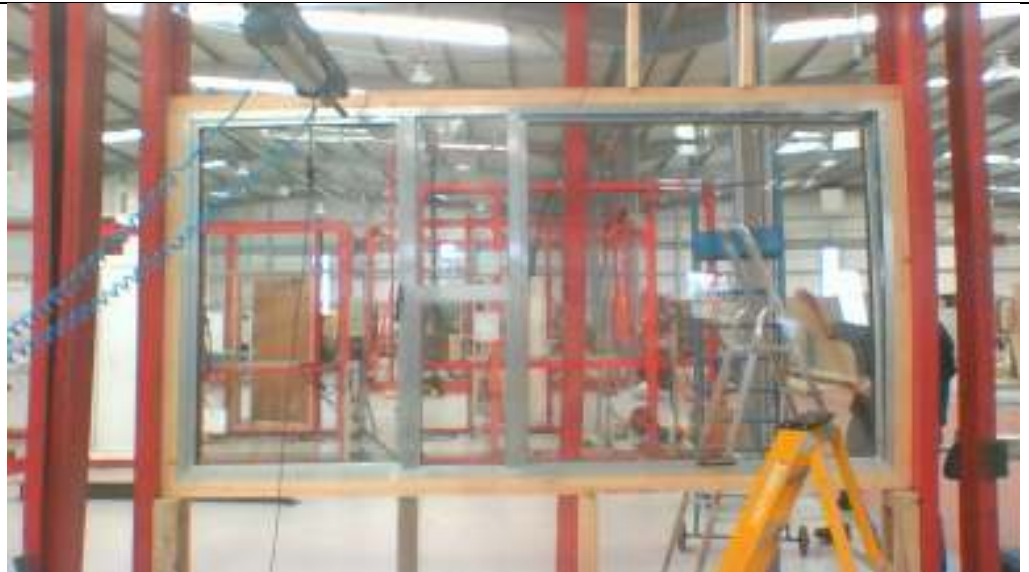
The internal face of the sample

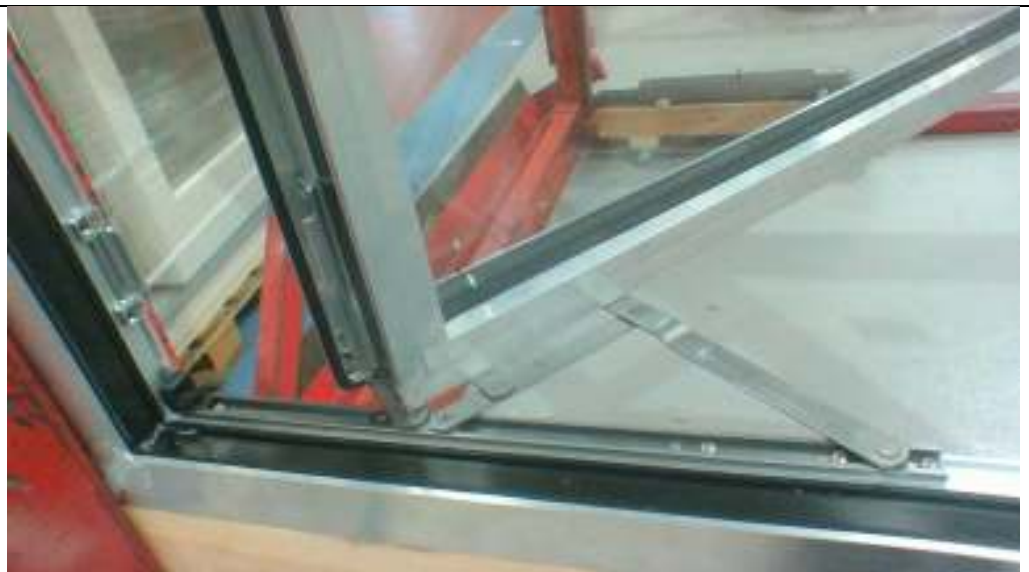
Sample hinge

Details of Hardware
 Hinges 2no. Senior Architectural side hung hinge SWFS16A
 2no. Senior Architectural top hung hinge SPW7HS24

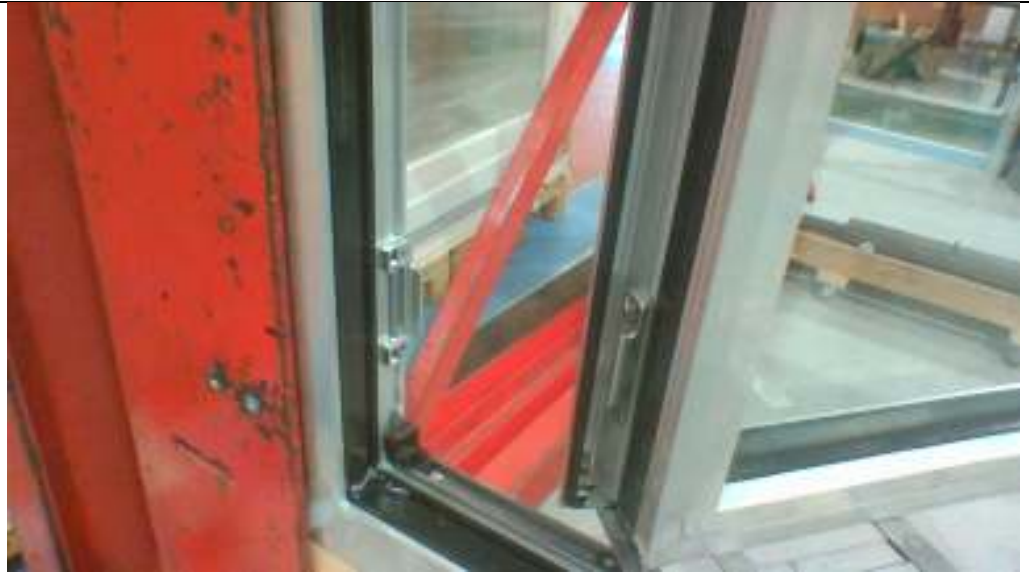
Sample hinge protector

<u>Item</u>	<u>Description</u>
16. Hinge protectors	
Supplier	: SENIOR ARCHITECTURAL SYSTEMS LTD
Description	: Hinge protector
Reference	: HCMA353309SC
Material	: Metal
Quantity	: 4No. Per Window
Position	: 105mm in from the vent edge
Fixing device to casement

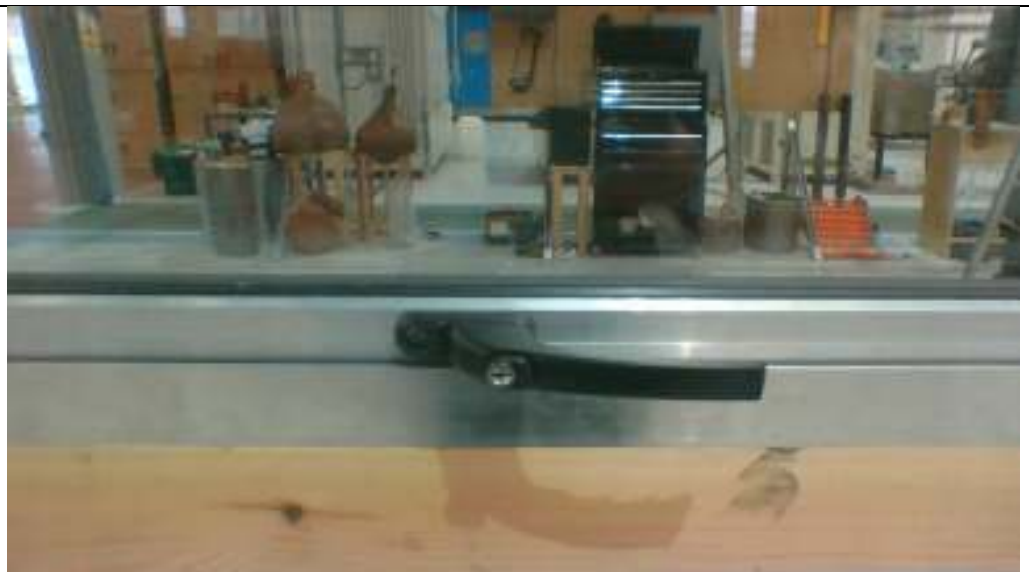
Sample handle

i. type	: SFSCS07 SFSCS0819
ii. size	: No.8x16mm No.8x19mm
iii. quantity	: 2No. Per Keep One No. Per Keep
19. Lever handles	
Supplier	: SENIOR ARCHITECTURAL SYSTEMS LTD
Description	: Espag Handle Plus Spindle
Reference	: INLINEB & SPIN9MM
Material	: Metal
Fixings

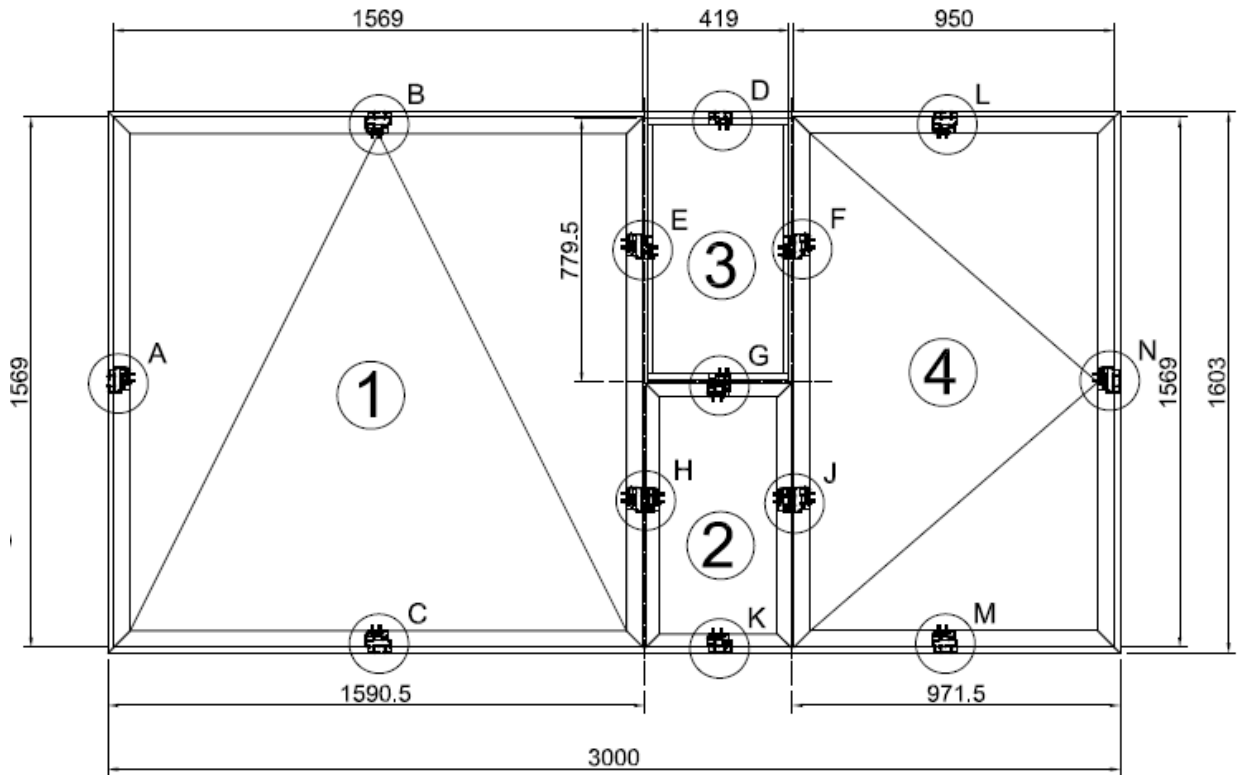
Figure 1- General Elevation of Test Specimen (External Face)

Outer frame 3000 x 1600 x 68mm
 Opening casements TH: 1570 x 1570 x 68mm
 FIXED: 430 x 780mm
 SH: 950 x 1570mm

Configuration Top hung next to direct glazed over fixed light next to side hung
 Material Aluminium

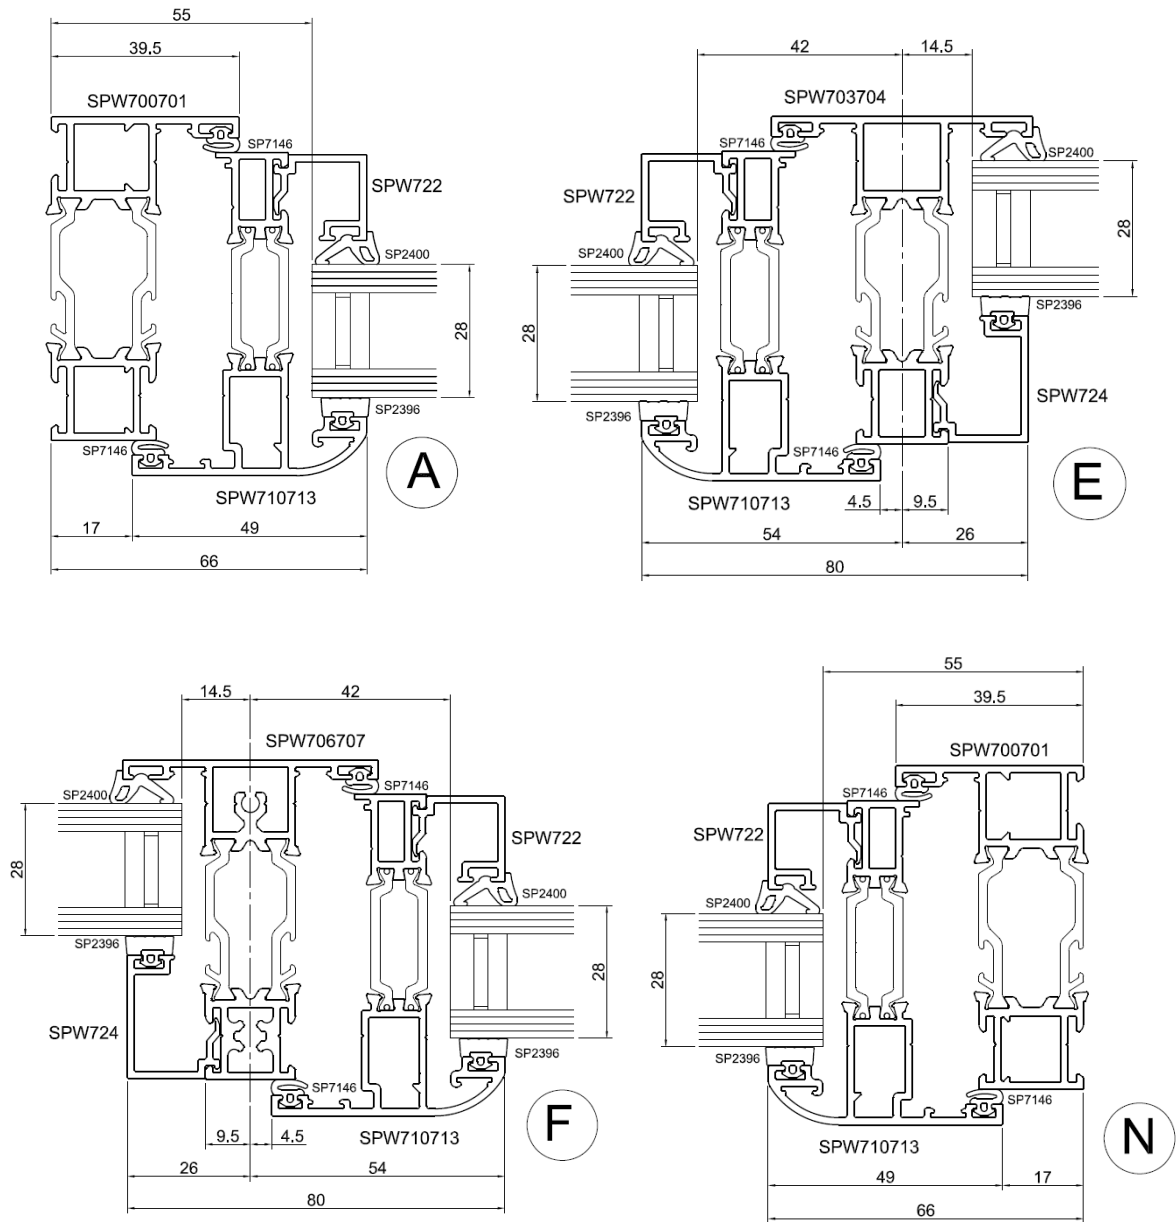
Figure 2 – Horizontal section through top hung, direct glazed and side hung

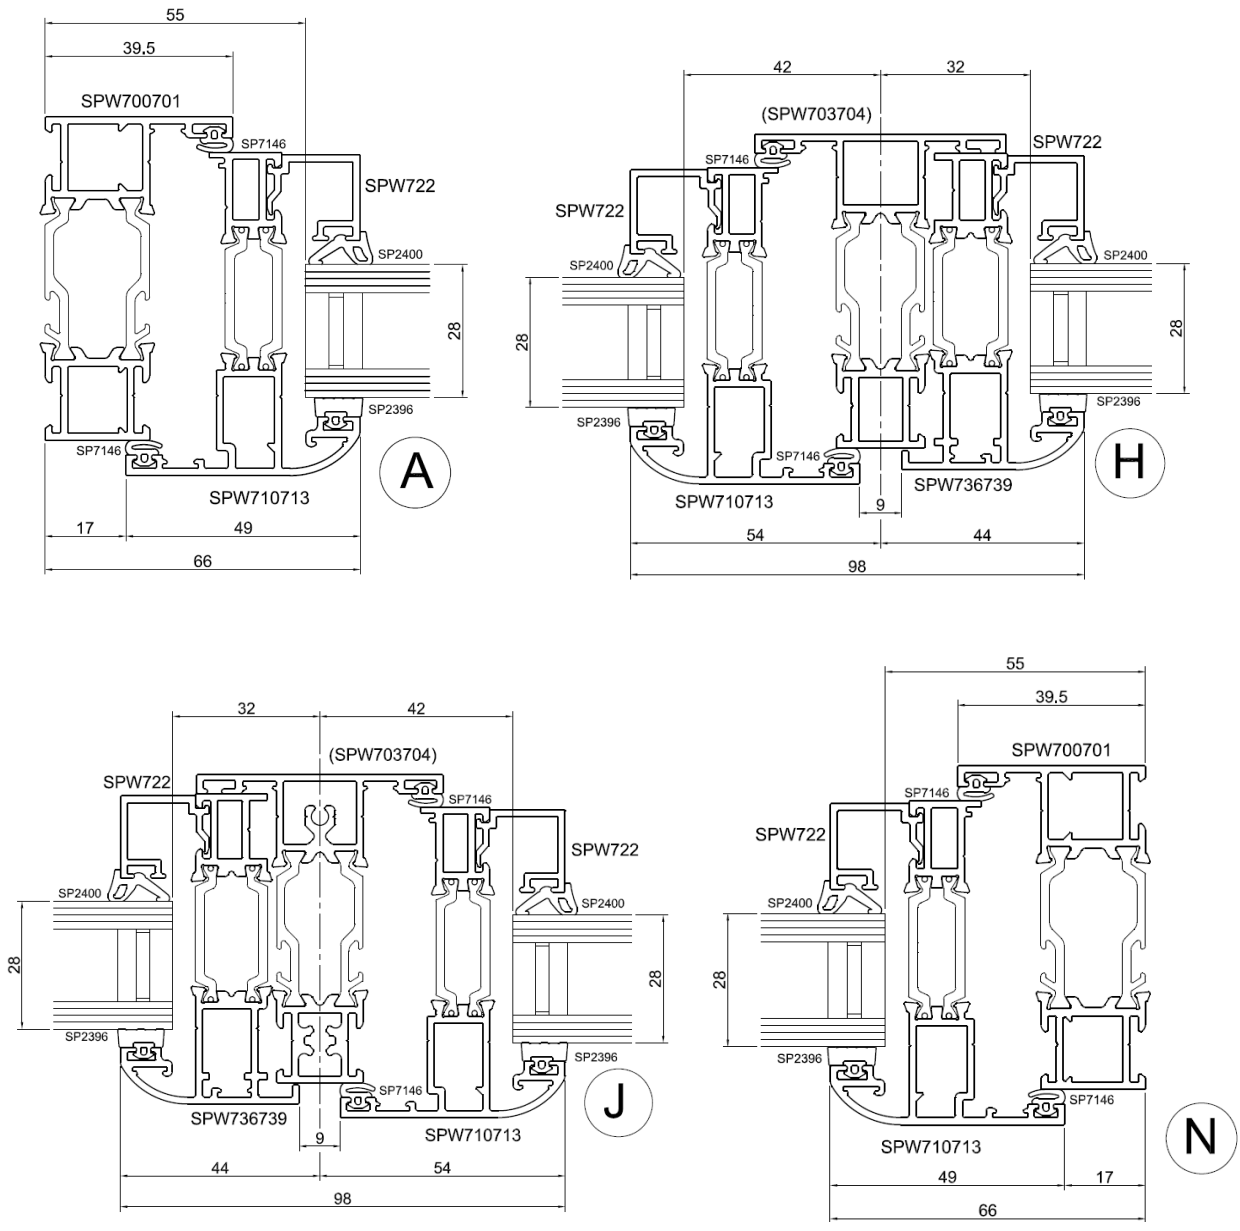
Figure 3 – Horizontal section through top hung, fixed and side hung

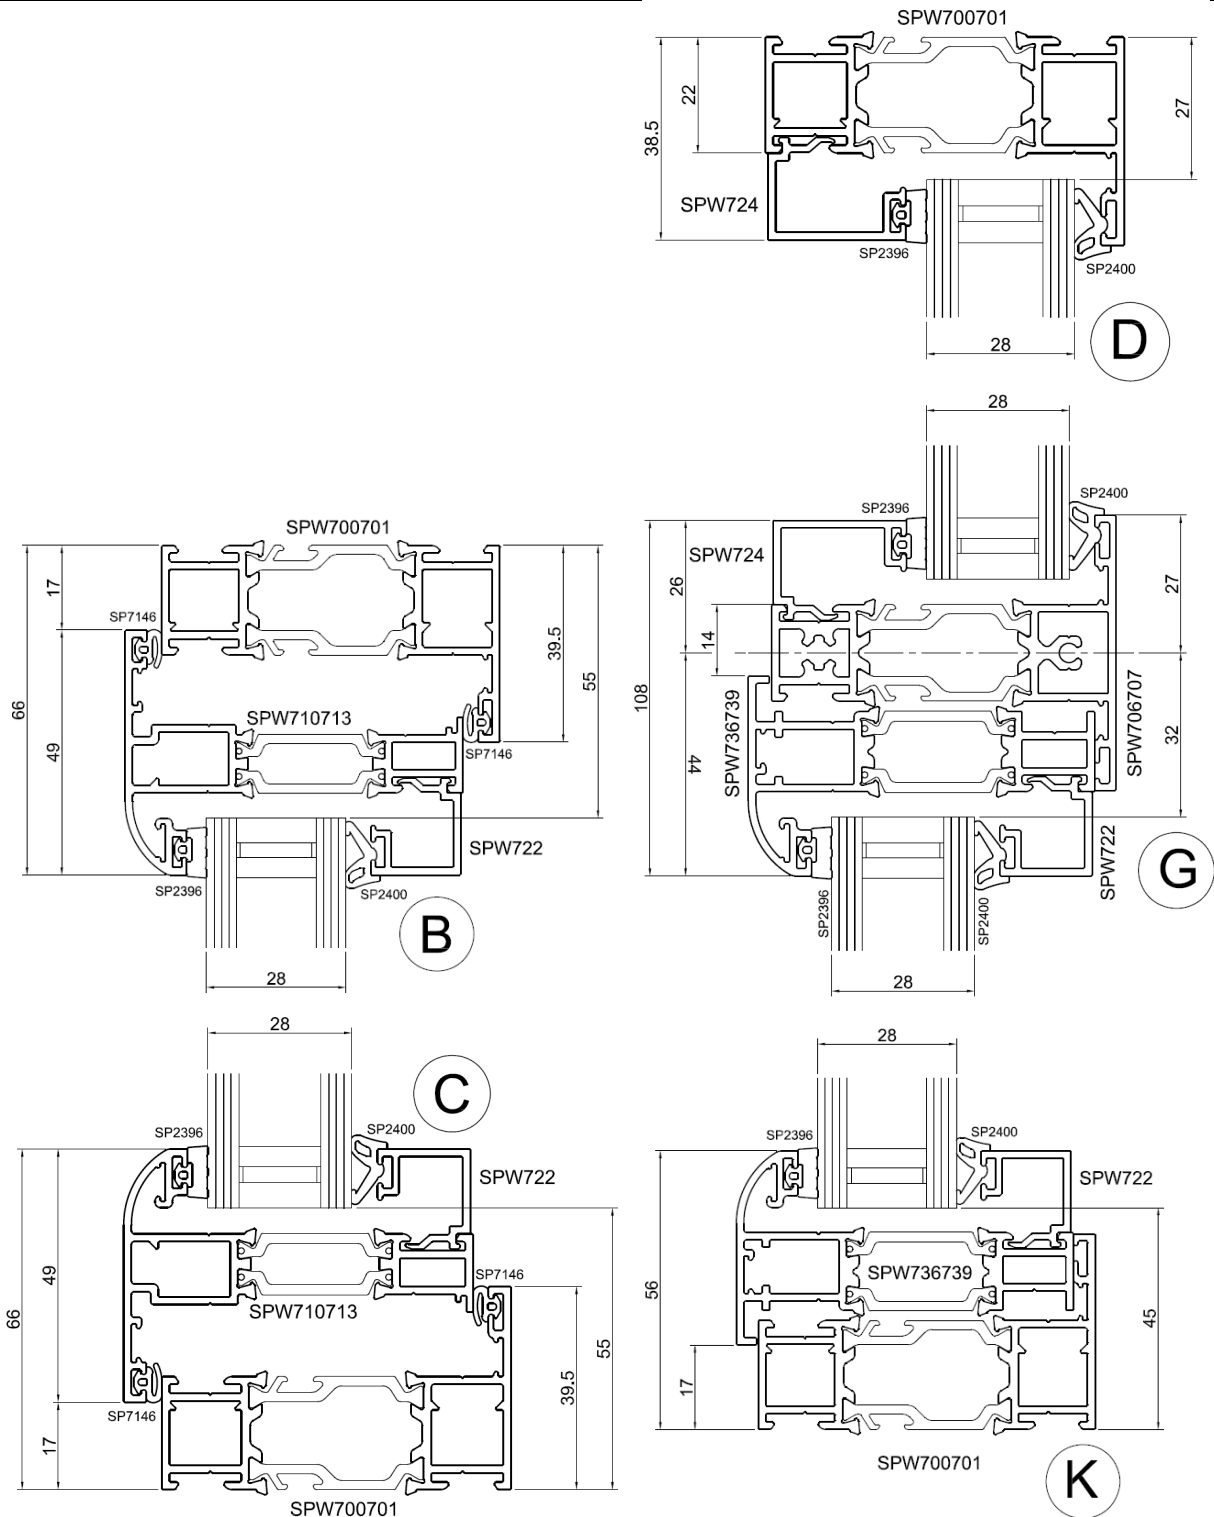
Figure 3 – Vertical section through top hung/side hung and fixed/direct

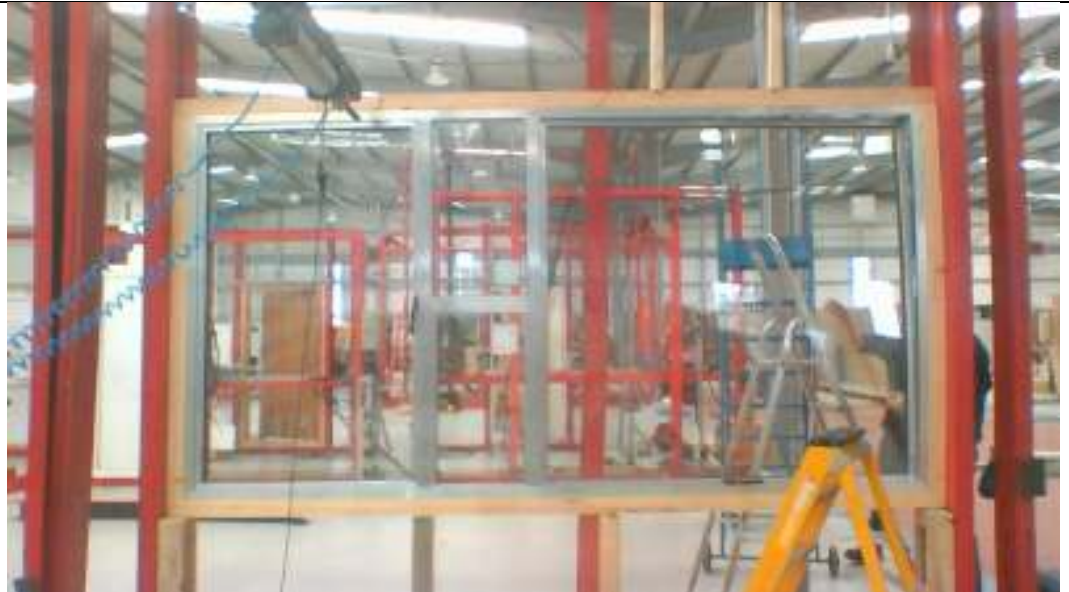
Defined mechanical loading points

C.4.5 Mechanical loading test – Side hung casement	<p>Attempts to apply Mechanical loads to all the hinge points and locking points were made with the following results obtained.</p> <p>Point 1: Top hinge/vector excluder 1kN parallel load (down) and 3kN perpendicular load held for 10s. 1kN parallel load (horizontal) and 3kN perpendicular load held for 10s.</p> <p>Point 2: Free corner 1kN parallel load (across) and 3kN perpendicular load held for 10s. 1kN parallel load (up) and 3kN perpendicular load held for 10s.</p> <p>Point 3: 1st locking point 1kN parallel load (across) and 3kN perpendicular load held for 10s. 1kN parallel load (across) and 3kN perpendicular load held for 10s. 1kN parallel load (up) and 3kN perpendicular load held for 10s.</p> <p>Point 4: 2nd locking point 1kN parallel load (across) and 3kN perpendicular load held for 10s. 1kN parallel load (across) and 3kN perpendicular load held for 10s. 1kN parallel load (up) and 3kN perpendicular load held for 10s.</p> <p>Point 5: 1st locking point 1kN parallel load (across) and 3kN perpendicular load held for 10s.</p>	PASS

Clause	Result	Pass / Fail
	<p>1kN parallel load (across) and 3kN perpendicular load held for 10s. 1kN parallel load (up) and 3kN perpendicular load held for 10s.</p> <p>Point 6: 1st locking point 1kN parallel load (across) and 3kN perpendicular load held for 10s. 1kN parallel load (across) and 3kN perpendicular load held for 10s. 1kN parallel load (up) and 3kN perpendicular load held for 10s.</p> <p>Point 7: Free corner 1kN parallel load (across) and 3kN perpendicular load held for 10s. 1kN parallel load (up) and 3kN perpendicular load held for 10s.</p> <p>Point 8: Top hinge/vector excluder 1kN parallel load (down) and 3kN perpendicular load held for 10s. 1kN parallel load (horizontal) and 3kN perpendicular load held for 10s.</p> <p>All loads were held and no entry was achieved.</p>	
C.4.5 Mechanical loading test – Fixed casement	<p>Attempts to apply Mechanical loads to all the hinge points and locking points were made with the following results obtained.</p> <p>Point 1: 1st fixing 1kN parallel load and 3kN perpendicular load held for 10s.</p> <p>Point 2: 2nd fixing 1kN parallel load and 3kN perpendicular load held for 10s.</p> <p>Point 2: 2nd fixing 1kN parallel load and 3kN perpendicular load held for 10s.</p> <p>Point 2: 2nd fixing 1kN parallel load and 3kN perpendicular load held for 10s.</p> <p>Point 2: 2nd fixing 1kN parallel load and 3kN perpendicular load held for 10s.</p> <p>Point 2: 2nd fixing 1kN parallel load and 3kN perpendicular load held for 10s.</p> <p>All loads were held and no entry was achieved.</p>	PASS
